## Minimizing Safety Risks during Facility Dismantlement

The dismantlement of the 704-R Building provides an example of effective use of specialized equipment to get a job done quickly, efficiently, and safely.

FACILITIES DECOMMISSIONING DIVISION

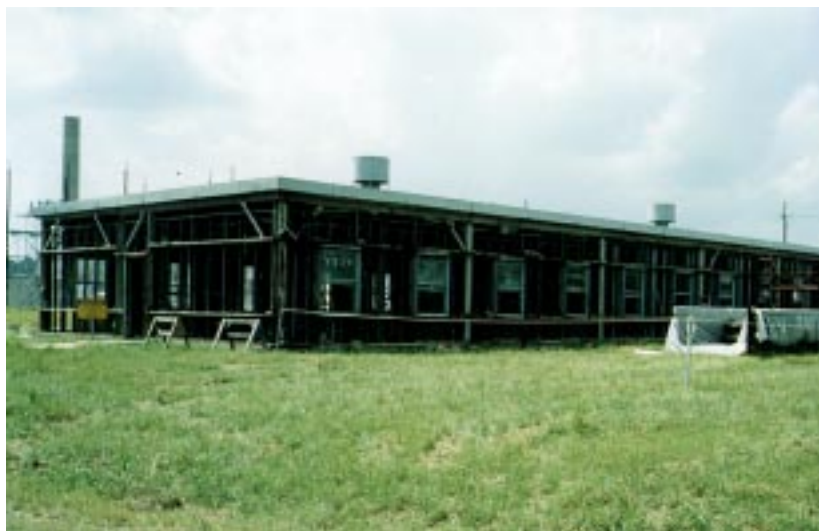
*704-R building during removal of the siding. This facility was originally an administration building and maintenance area during the operation of R Reactor.*

The 704-R building was originally an administration building and maintenance area used during the operation of R Reactor. This L-shaped building, composed of a metal frame with a concrete slab roof measuring approximately 18,600 square feet, was built in 1953. The structure was almost entirely enclosed in asbestos material with transite exterior panels. Interior walls, floor tile, mastic, roofing, and insulation materials contained asbestos. Used for a period of time as a radioactive material storage area, the facility was subsequently rolled back and released as a clean facility.

Because of the poor condition of exits and egress paths and insect infestation, this facility constituted a safety hazard. To eliminate these hazards and provide a lay-down area for future activities at R Reactor, 704-R was scheduled for dismantlement and removal (D&R).

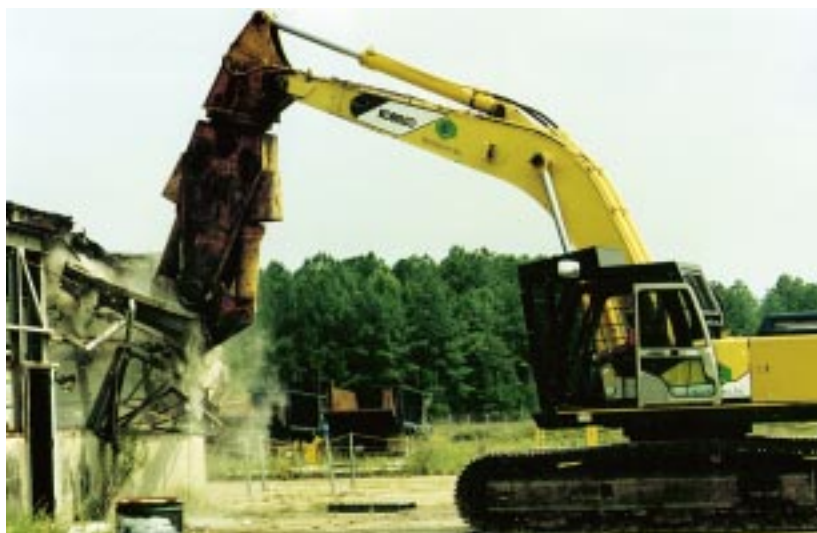
*704-R dismantlement using a hydraulic power shear attached to a track hoe.*

The construction crew wasted no time in getting the work done. They acquired a large track hoe with a hydraulic power shear attachment to cut, rip, and shear steel frame members ranging in size from 10 to 18 inches. Within 17 working hours, the entire structure was reduced to massive piles of twisted steel beams and concrete rubble.

Using the right piece of equipment for the job significantly reduced safety risks. This process eliminated dismantlement hazards associated with burning notches in beams and columns, falling debris, elevated work, and lead paint exposure. The job was completed without a single injury or first aid case to any of the workers.

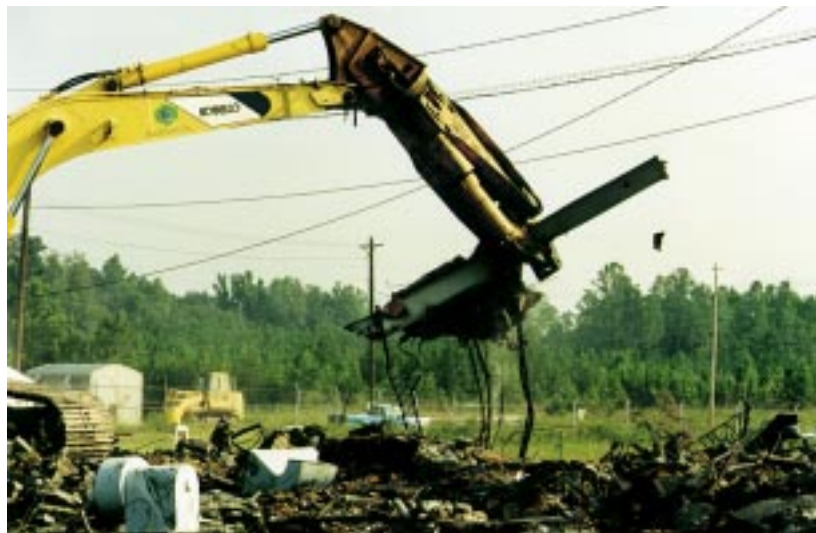
*The shear attachment was used to easily cut the steel frame members and quickly separate the scrap.*

By using the power shear, the construction crew reduced manpower requirements by half. Approximately three months of work (the time required for use of a torch and pulling down the building with a piece of heavy equipment) were saved. As a result of the construction crew's innovation and safety attitude, the 704-R building dismantlement was a complete success.
